Awnings

Roofs

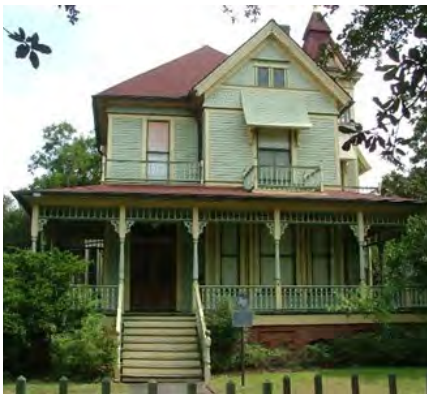
Awnings are still present on the Milroy House today.

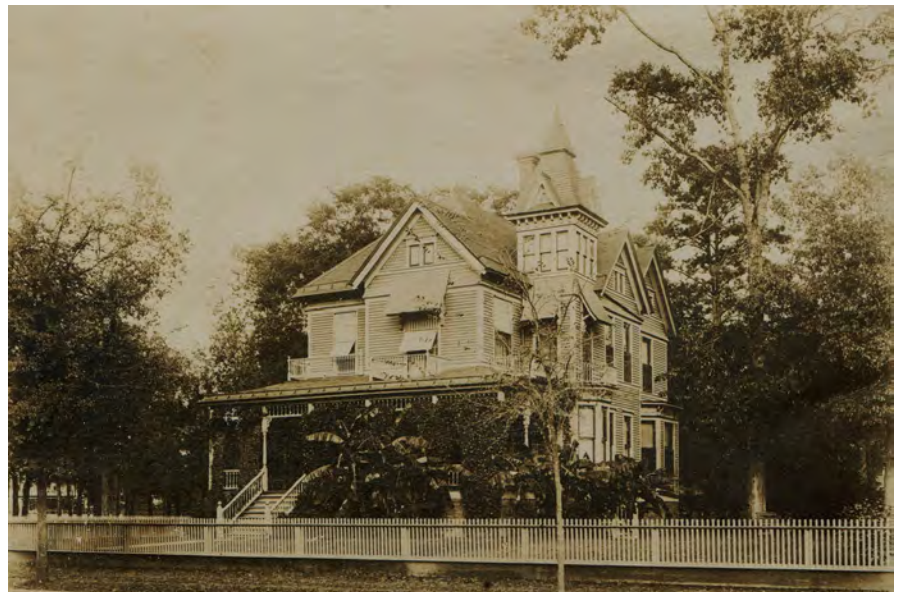
Awnings are visible on the Milroy house in this historic photo (courtesy of Randy Pace).

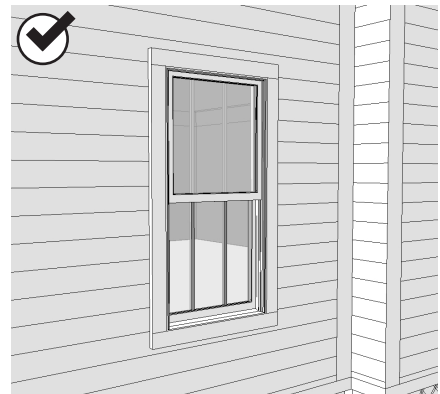
Locate burglar bars inside the structure, if possible.

- Locate security bars inside the structure, if possible.
- Avoid an ornate design that would be out of character with the historic building.

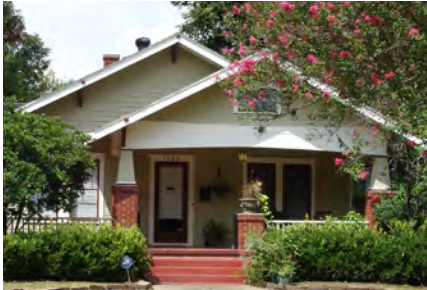
A front gabled roof

Many roofs on older residential buildings have one of the following shapes: gabled, hipped, pyramidal, hip-on-gable, gable-on-hip, or some combination. Roof shapes may be simple or complex; they may be sloped with a steep pitch or a low pitch. Craftsman roofs typically have a 5-over-12 or 6-over-12 pitch, while Queen Anne roofs are steeper, with an 8-over-12 pitch or higher.

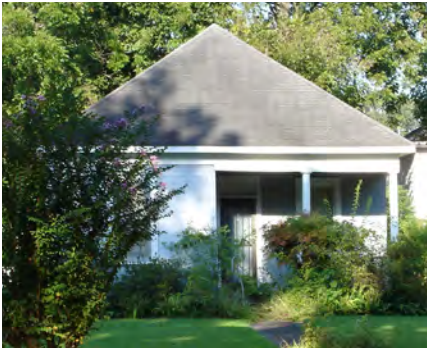
A hipped roof

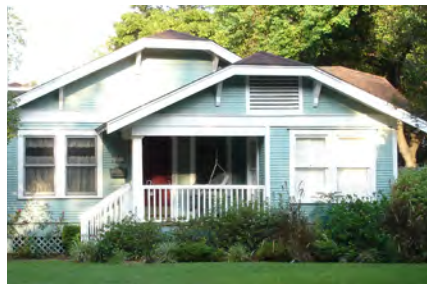
A hip-on-gable roof
